Report 2269

FAMILY OF MILITARY ENGINEER
CONSTRUCTION EQUIPMENT (FAMECE)
PROTOTYPE QUALIFICATION
TEST-GOVERNMENT (PQT-G)
TEST REPORT

March 1979

U.S. ARMY MOBILITY EQUIPMENT
RESEARCH AND DEVELOPMENT COMMAND
FORT BELVOIR, VIRGINIA

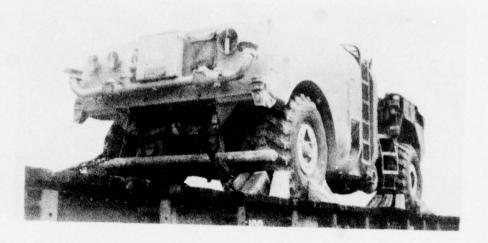
Figure 2.3-14. Distributor — rail transportability test results.

Test No.	Impact Speed		Results
NO.	(mi/h)	Power Module	Work Module
1	4.00		Clevis on curbside failed. Clevis was replaced and test continued.
2	5.87		Chains loose (retightened).
3	8.11		Chain elongated, reached limit.
NOTE:	New chains	installed prior to	conducting tests 4, 5 and 6.
4	4.30		
5	6.02	Chains loose (retightened).	
6	8.11

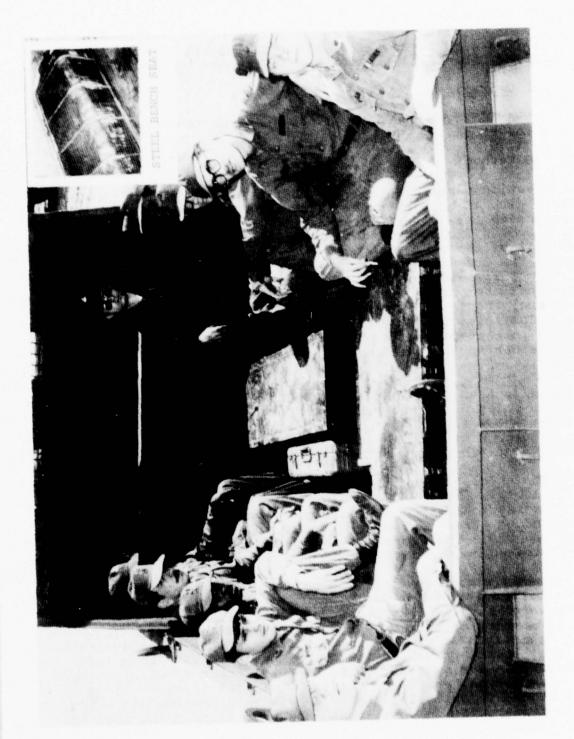
Figure 2.7-1. Engineers and tool kits in dumper.

in this test, the kits were not tied down in the 5-ton truck. The FAMECE does not have provisions for tying down equipment carried in the bed of the dumper. After the test, the participants were asked to fill out a questionnaire which asked for a comparative rating of different aspects of the vehicles.
